TSI - 技术服务报告

产品线 Product Line	设备名称 Machine Name	设备型号 Machine Model	出厂编号 Machine Serail No.	交付日期 Delivery Date	故障日期 Failure Date
混凝土	混凝土泵车 Truck mounted	ZOOMLION 43-5RZ	016515A222H007	2023/10/18	2023/10/18

事件简述 Brief Description	客户购买我公司混凝土泵车，2023年10月18日在柏倍拉港口卸货吊装中发生侧翻，泵车向左翻倒，造成左侧支腿、转台、臂架等多处损坏。 The customer purchased our company's concrete pump truck, which overturned during unloading and hoisting at the Port of Babel on October 18, 2023. The pump truck tipped over to the left, causing damage to the left leg, turntable, boom,	故障阶段 Failure Period	故障系统 Faulty System	故障责任判定 Damage Reason
		交付前	臂架总成	运输

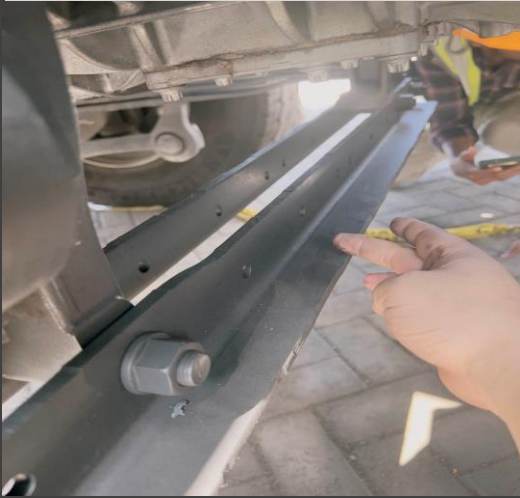
1. It was found that there were traces of oil leakage in the chassis gearbox, a large area of oil leakage on the ground under the gearbox, and a bolt in the gearbox was broken.

- 底盘齿轮箱漏油
- Chassis gearbox oil leakage

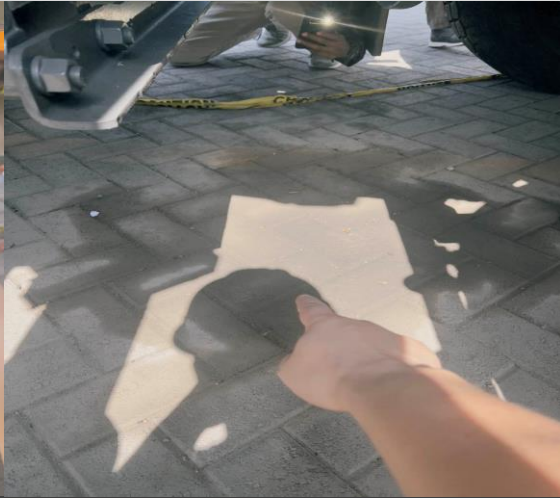
- 底盘齿轮箱漏油
- Chassis gearbox oil leakage

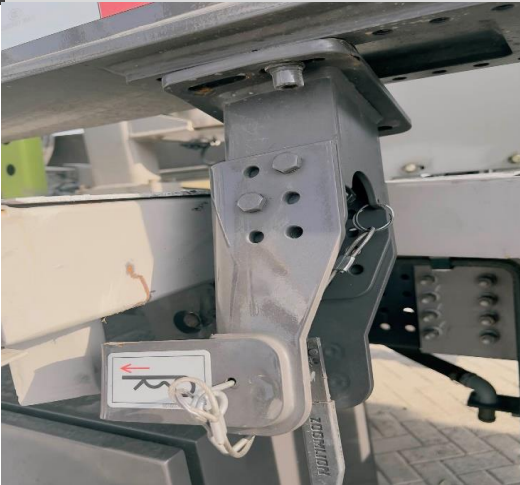
- 支腿锁断裂
- Broken of the rear outrigger lock

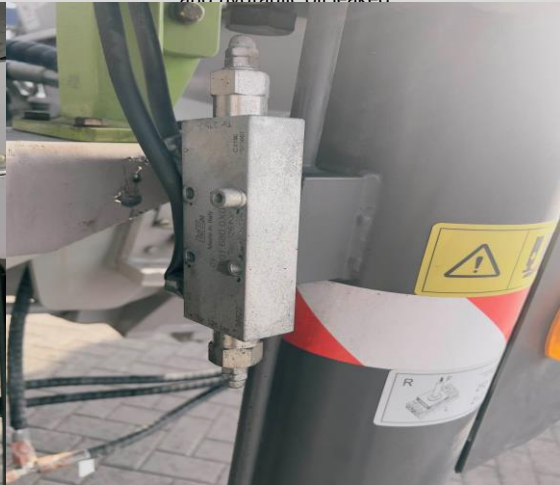
2. The left outrigger was deformed due to external impact. There was a quasi-circular penetration damage of about 2*8CM. There were strain marks on the vertical welds of the outrigger webs, and scratch marks were visible in many places. On the left side The outrigger hydraulic lock was displaced and there were traces of hydraulic oil leakage; the left outrigger lock fixing bolt was broken.

- 左后支腿液压锁移位，有液压油漏出
- The hydraulic lock of the left rear outrigger was displaced and hydraulic oil leaked

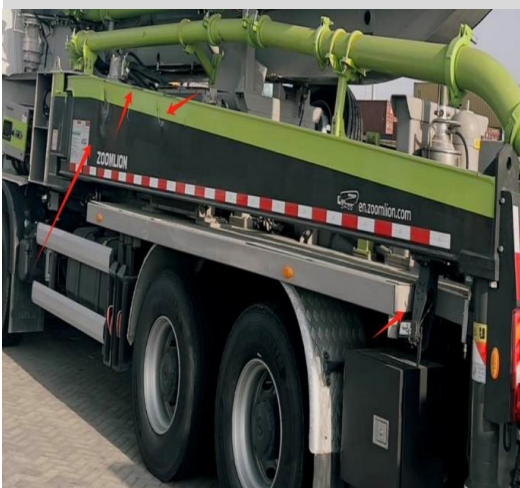
- 左后支腿损伤情况
- Left rear outrigger condition

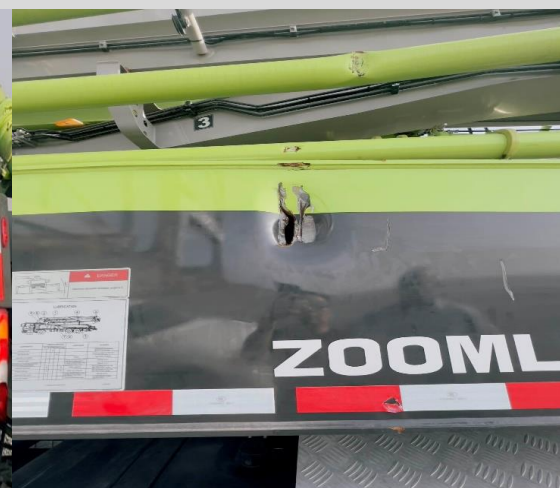
- 左后支腿损伤情况
- Left rear outrigger condition

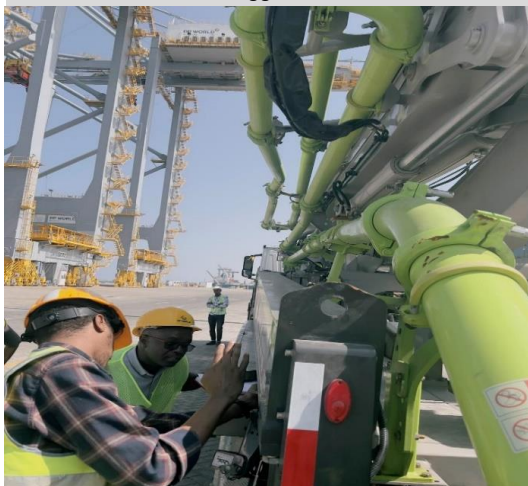
- 左后支腿发生变形
- The left rear outrigger is deformed

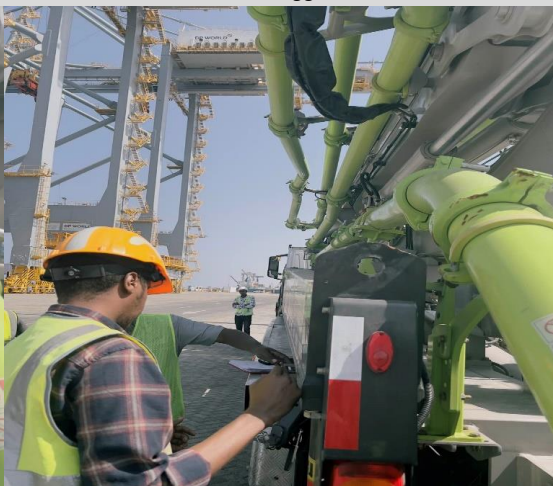
- 左后支腿发生变形
- The left rear outrigger is deformed

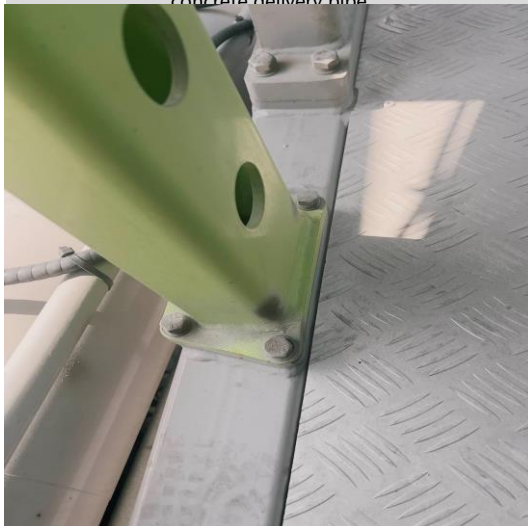
4. The inspection found that the concrete delivery pipe between the hopper outlet and the #1 arm was extruded and deformed, the two pump pipe supports were deformed to the right due to external force, and there were signs of strain on the bottom of the pump pipe supports.

- 混凝土输送管底部支撑变形、开裂
- Deformation and cracking of the bottom support of the concrete delivery pipe

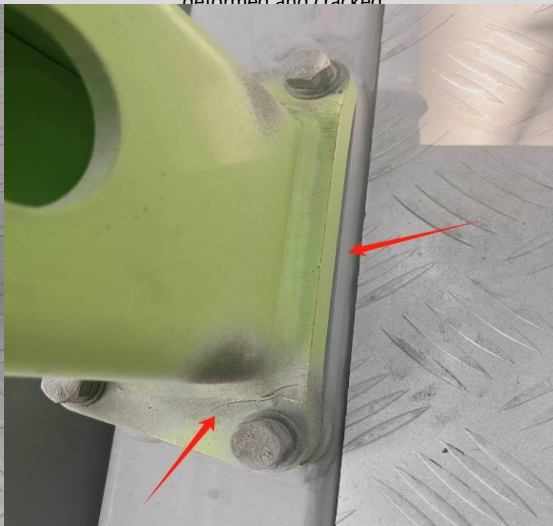
- 混凝土输送管底部支撑变形、开裂
- The bottom support of the concrete delivery pipe is deformed and cracked

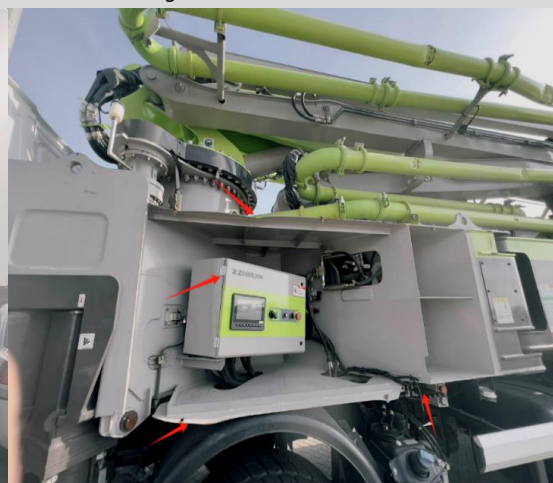
3. The inspection found that the door of the electrical control cabinet fell off, the entire electrical control cabinet was deformed, a wire harness broke inside the electrical control cabinet, and the door inside the electrical control cabinet was deformed and could not be closed normally.

- 电控柜受损情况
- Damage to the electrical control cabinet

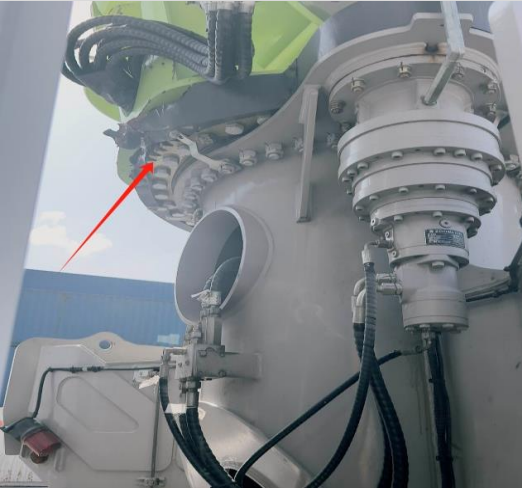
6. The inspection found that the large gear cover of the pump truck's turntable near the cab side was crushed and damaged, and the large gear of the turntable was exposed. Rotary motor oil cup cracked.

- 转台受损情况
- Damage of the rotatesupport

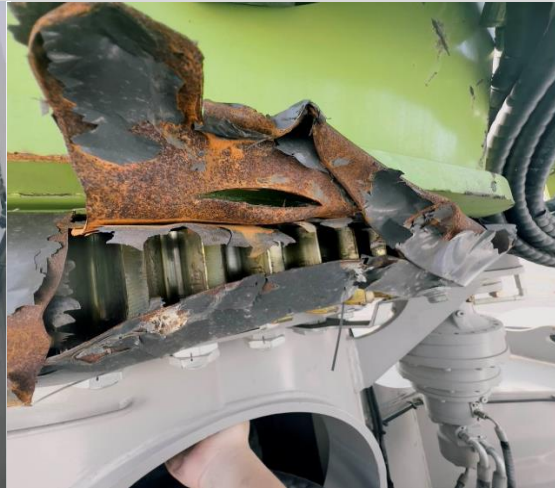
- 转台受损情况
- Damage of the rotatesupport

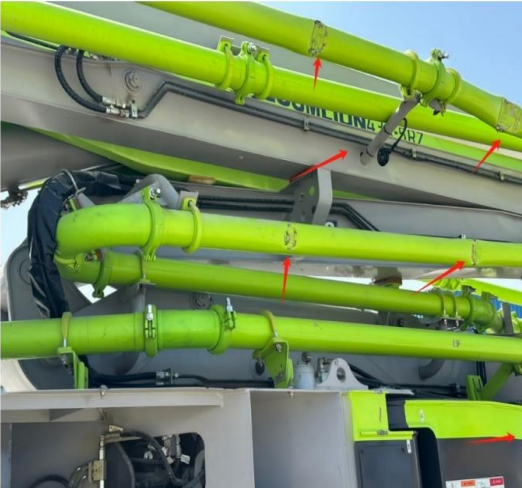
- 混凝土输送管受损情况
- Damage of the concrete delivery pipes

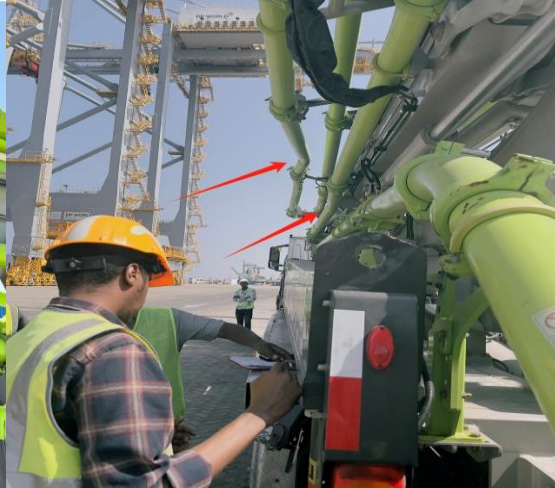
- 混凝土输送管受损情况
- Damage of the concrete delivery pipes
